October 26, 2011

RE: On-site damage inspection report – Town of Oakland Garage

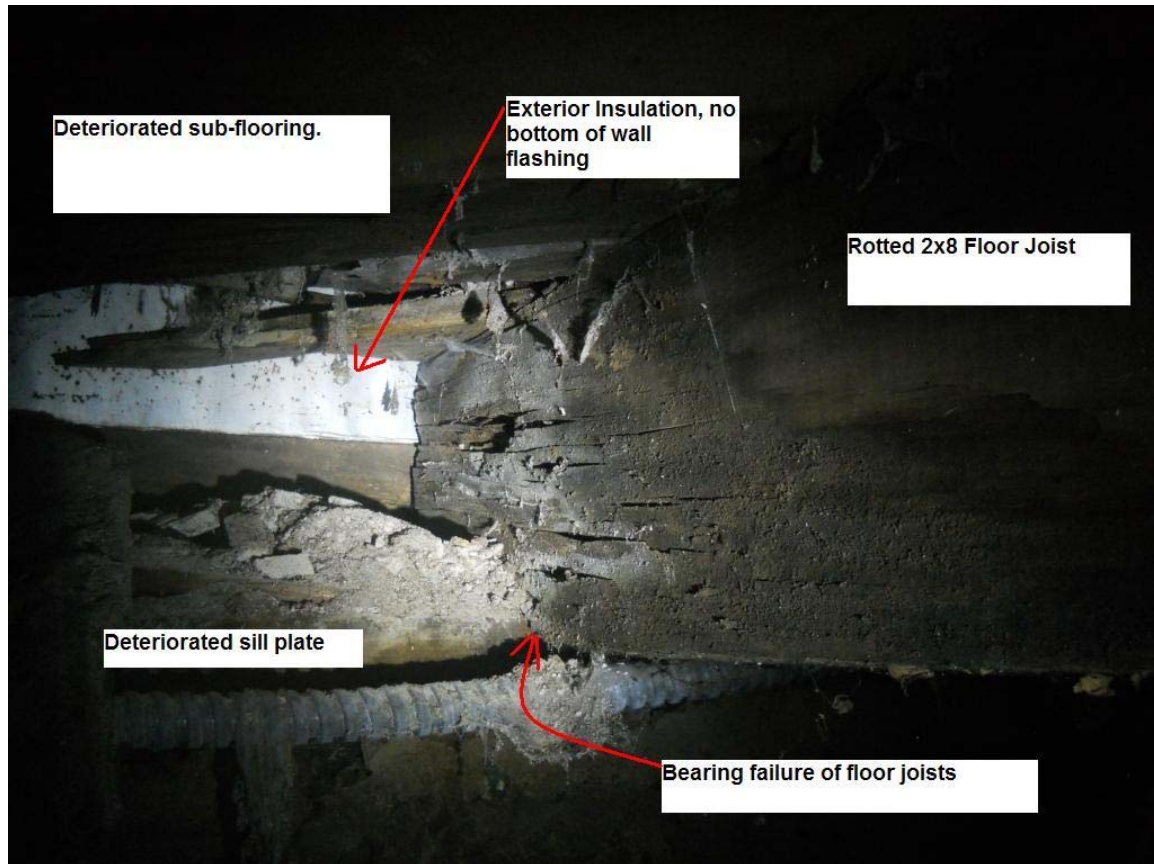
**Figure 2: North Foundation Wall with Observations**

wall. Figure 2 shows a rotted floor joist bearing condition where it meets the sill along the north wall. In this case the joist and sill are both showing severe deterioration with the joist failing in bearing. The portion of sub-floor nearest the wall is also failing, and the rim joist has been removed entirely leaving the exterior insulation exposed.

1. Deterioration of the floor joists and sub-flooring. All of the floor joists bearing along the North wall are deteriorated to some extent. In places, the subflooring is deteriorated as well. This deterioration has progressed to the point of failure in several locations, which is likely contributing to the un-evenness of the floor above. While the joists are currently failing, the likelihood of an ultimate collapse failure under normal foot traffic is very low. Large point loads (greater than 1000 lbs.) should not be placed along this wall.
2. Inadequate roof framing. The existing roof framing consists of site-built kingpost trusses with 2x4 top chords and 2x6 bottom chords and 1x4 web members. The existing compression web members, which are meant to provide support to the top chords are far too slender to provide meaningful support, leaving the 2x4 top

- a. Raise and support entire structure just enough to allow removal and replacement of existing sills.
- b. Remove and replace sill and rim joist. This would likely involve abrasive cutting of existing anchors and nailing.
- c. Install Simpson strong tie strap anchors to re-anchor floor framing to the sill and sill to the foundation.
- d. Sister deteriorated floor joists with new 2x8 joists. Assume replacement of all joists along north wall and half of south wall for budgetary purposes, Approximately 75 joists in total.
- e. Deterioration may extend into wall bottom plate and studs along north wall. Extent of repairs to be determined upon inspection. For budgetary purposes, assume replacement of 10' of North wall framing, including one window will be required. Include temporary shoring of roof trusses, and allowance for replacing sheathing and siding on either side of opening.

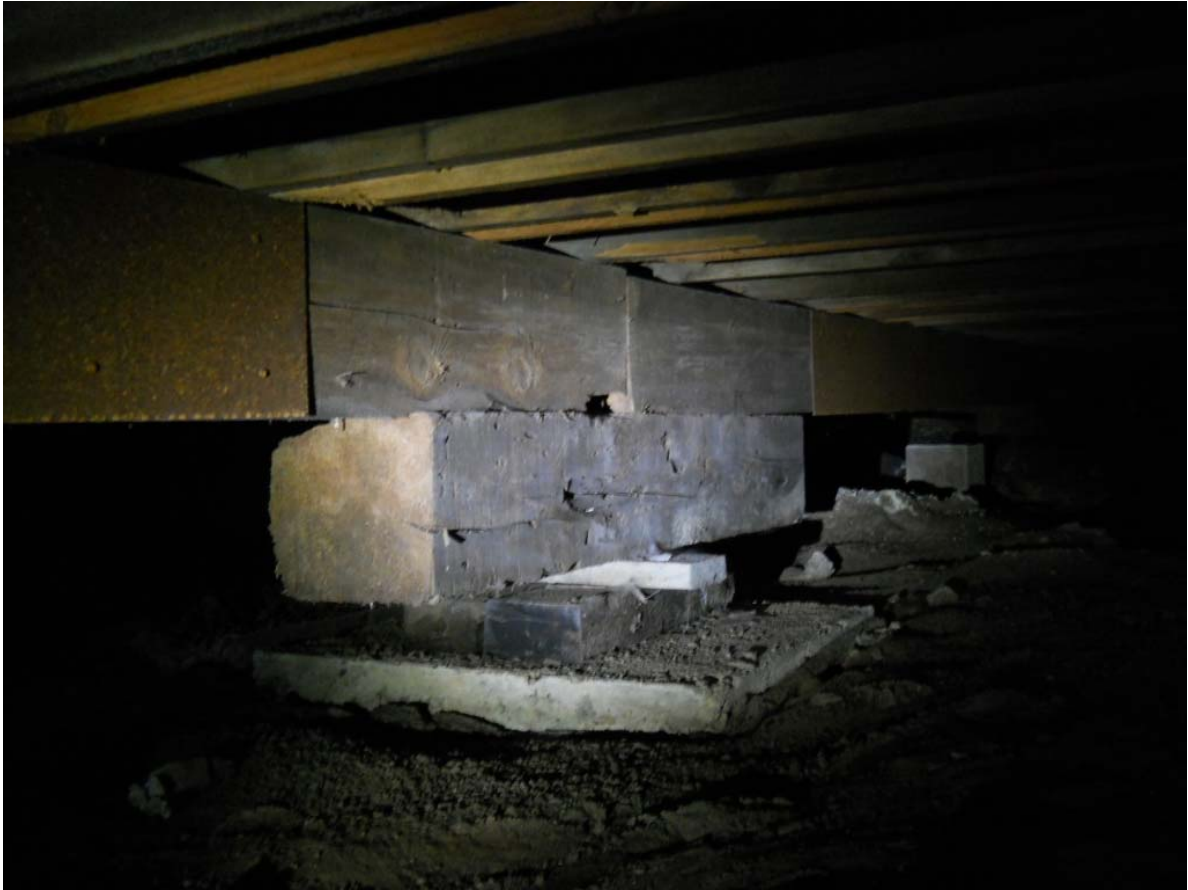
**Figure 3: Interior Bearing Beam and Concrete Pier.**

The beams forming the interior bearing lines also showed evidence of deterioration along the bottom surfaces of the beams. The deterioration extended to a depth of approximately one inch into the cross section of the beams. The beams do not yet show evidence of overload, however further structural analysis would be required to determine the reduction in load capacity due to cross section loss. Figure 3 shows a typical interior support beam and concrete pier.

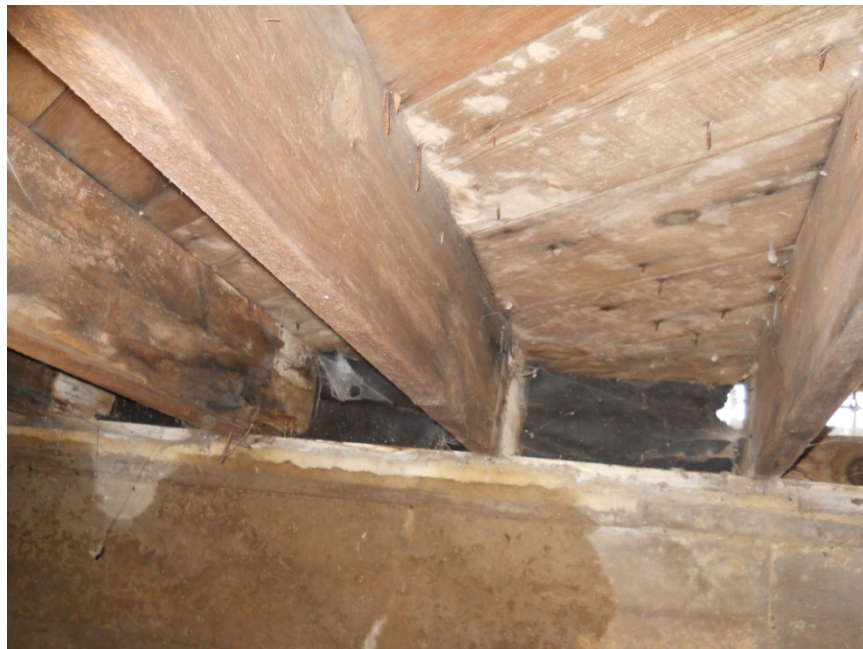
**Figure 4: Moisture along inside face of North Wall**

The second source of moisture is infiltration of rainwater directly along the North wall above as a result of water shedding from the roof and wind driven rain. Figure 4 shows moisture observed extending downward from the North Sill during inspection. Several locations on the North wall were currently wet, or showed signs of efflorescence, the

evaporative salt deposits left on concrete walls that are frequently wet over a long period of time. It was noted during the inspection that there was no visible bottom of wall flashing, or modern weather resistive barrier installed on the building. The roof and attic of the structure were inspected show no signs of significant moisture infiltration, and appear to be in good condition. The interior wall construction was also checked and found to have a vapor barrier and insulation. With the roof, and interior ruled out as sources of moisture, it was concluded that the likely source of the moisture from the North Wall is wind-driven rain and water shedding from the roof above. Water and moisture in direct contact with this wall are not being properly resisted by a barrier or drained by flashing. This moisture, infiltrating directly from the north wall is likely the cause of the extensive deterioration of floor framing at the North wall bearing.

- a. Remove siding along North side of building.
- b. Remove bottom row of rigid insulation.
- c. Inspect rim joist, sill and bottom plate of wall along entire length of wall.
- d. Install custom galvanized flashing along entire north sill.
- e. Install modern weather resistive barrier (Tyvek or similar).
- f. Reinstall siding and insulation.

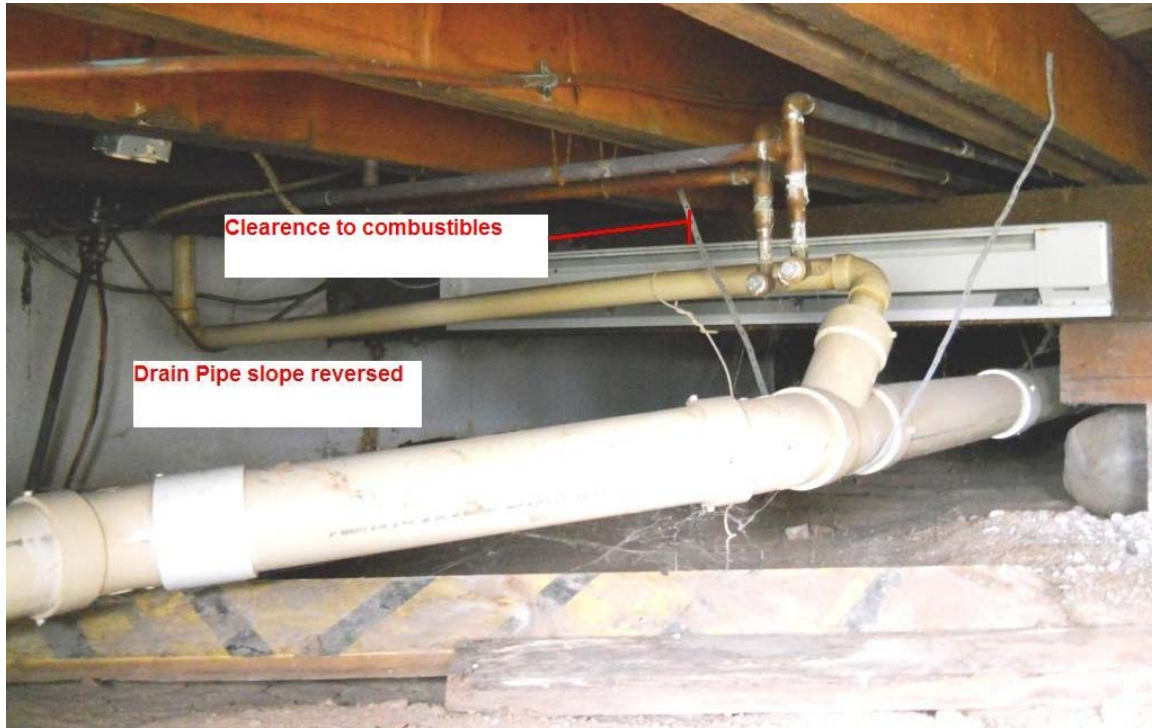
Figure 5: Mechanical Issues in Crawlspace

Although not the primary function of this inspection, there were two mechanical issues noted during the course of the structural inspection. Upon review by CMG & Associates, it was noted that the electric unit heater used in the crawlspace is likely in violation of required clearance to combustibles. The required clearances vary by manufacturer, however a typical residential unit similar to the one in the photograph below (Figure 5), with a low operating temperature, would require 18"-24" clearance above the unit to any combustible materials. This unit is likely mounted too close to the floor framing above. It was also noted that the sink drain in the photograph appears to have a slope which is reversed. CBE recommends that the drain slope be checked, and adjusted if necessary.

We recommend the unit heater be replaced with heated pipe tracers and pipe insulation as required to reduce the chance of freezing.
